**ENVIRONMENTAL  
ENGINEERING & CONTRACTING, INC.**

# PERFORMANCE EVALUATION OF THE TRAPZILLA® GREASE INTERCEPTOR AT A RETAIL DOUGHNUT BAKERY PRODUCTION FACILITY IN BEAVERTON, OREGON

**PREPARED FOR:  
THERMACO, INC.  
P.O. Box 2548  
ASHEBORO, NC 27204-2548  
NOVEMBER 15, 2012**

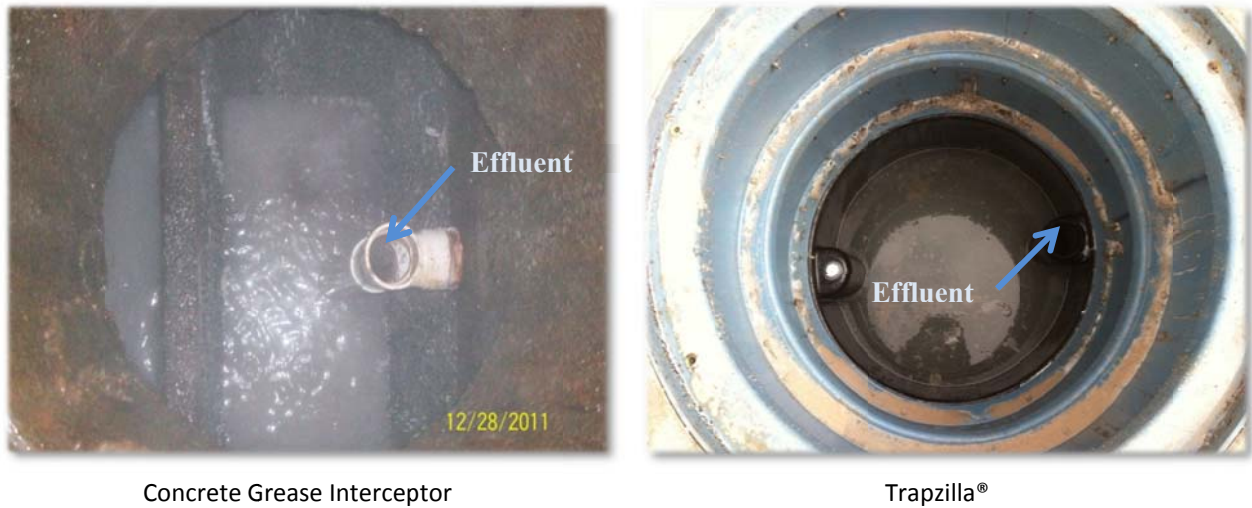
**Figure 4-1, Effluent Sample Collection Points**

The samples collected were analyzed for BOD, TSS, oil and grease, pH, and dissolved sulfide.

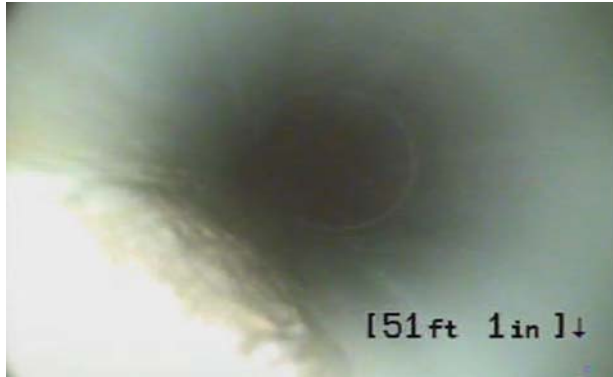
**Figure 5-1, CCTV Observations Downstream of the Concrete Grease Interceptor**

Baseline CCTV inspection of the concrete grease interceptor was conducted on December 14, 2012. Two weeks after the private sewer line was cleaned, a noticeable accumulation was observed in the private sewer line downstream of the concrete grease interceptor (Figure 5-1, *CCTV Observations of Concrete Grease Interceptor*). CCTV inspection was conducted before the concrete grease interceptor was removed on February 28, 2012, but that CCTV recording was lost due to technical difficulties. The Drain Away Rooter representative stated that significant accumulation was observed in the downstream private sewer line.

Private Sewer 51'1" Downstream of Concrete Grease Interceptor Immediately After Cleaning on 12/14/2011<sup>4</sup>

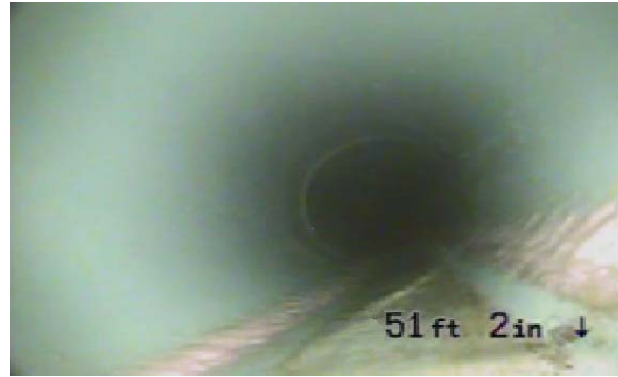
Private Sewer 51'2" Downstream of Concrete Grease Interceptor Two Weeks After Cleaning on 12/28/2011

The amount of accumulation observed in the downstream private sewer line was similar for both devices. However, CCTV Figures of the concrete grease interceptor taken two weeks after baseline conditions and Figures of the Trapzilla® unit taken two months after baseline conditions show less accumulation in the downstream sewer line after the installation of the Trapzilla®.

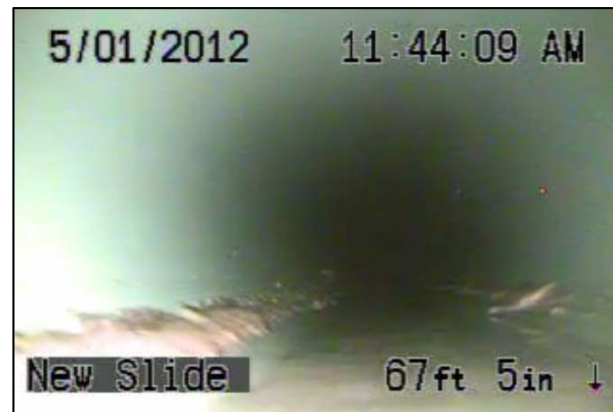
Figure 5-2, *CCTV Observations of the Trapzilla® Unit*, below compares the condition of the private sewer line 66 to 67 feet downstream of the Trapzilla® immediately and two months after the installation and cleaning.

Private Sewer 67' 5" Downstream of Trapzilla® Two Months After Installation and Cleaning on 5/1/2012

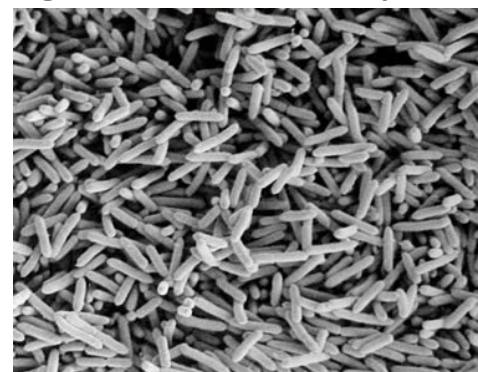
**Figure 5-4, Acetobacter Xylinum**

Another potential explanation for accumulation observed in the downstream sewer line is the presence of *Acetobacter*.<sup>6</sup> Scraping samples of the materials accumulated in the devices and downstream sewer line were collected periodically during the study period. The samples were sent to Sustainable Scientific Solutions for analysis, which confirmed the presence of *Acetobacter* in the samples. *Acetobacter* typically attaches to the walls of the devices and sewer lines in the form of cellulose. The *Acetobacter* breaks down the sugars and produces acetic acid. This could also account for the low pH discussed in Section 5.1.

Acetobacter Magnified 10,000 Times

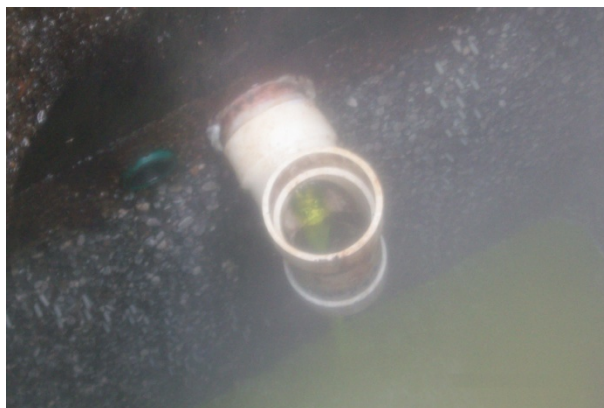
**Figure 5-5, Dye Testing Observations**

Figure 5-5, *Dye Testing Observations*, shows the presence of dye in the sewer system and concrete grease interceptor. The results of the dye test indicated that the majority of the grease wastes drained properly to the grease-control devices; one area of the facility's kitchen, however, drained directly to the sewer system. This area was identified as the station where coffee, cappuccino, and ice cream are made. The wastewater discharged in these drains could be a potential cause of accumulation in the downstream sewer system, and could account for the material accumulation seen in the CCTV images.

Dye Observed in Inlet of Concrete Grease Interceptor

It should be noted that the downstream accumulation could be due to discharge from the grease waste drain in the facility's kitchen area that was not connected to the grease-control devices (see Section 5.4). The facility will make the necessary plumbing changes to redirect the unconnected drain to the Trapzilla®.

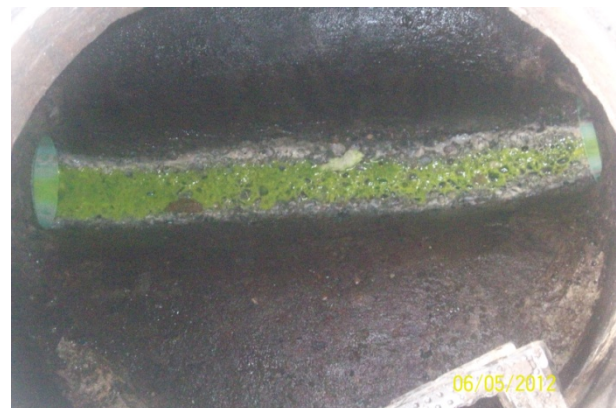
Dye Observed in Downstream Manhole of Private Sewer Line

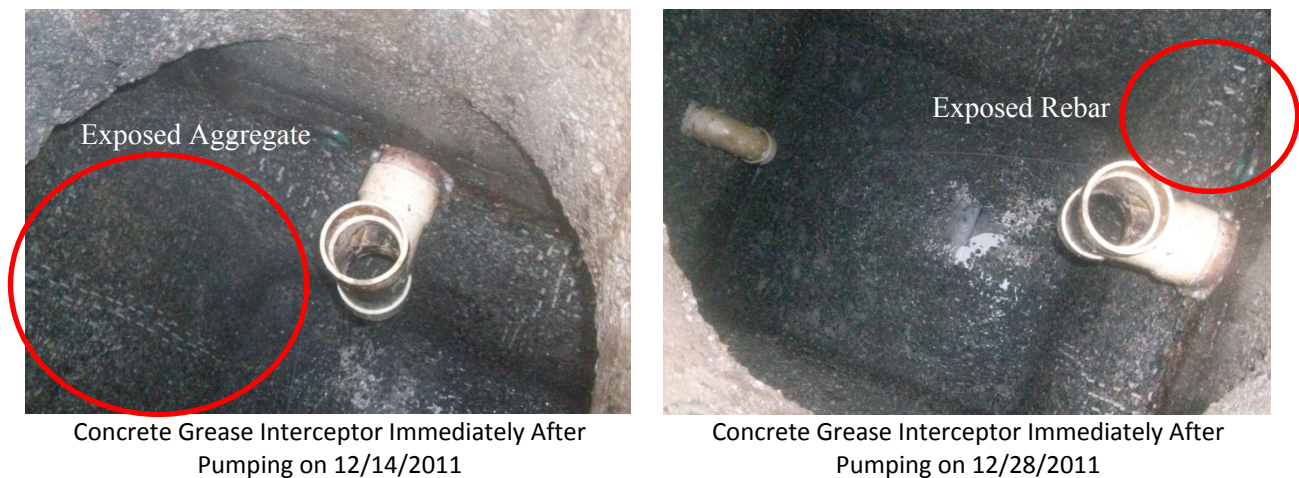
**Figure 5-6, Concrete Grease Interceptor Observations**

The City required the concrete grease interceptor to be pumped biweekly due to the deteriorated condition and apparent pass-through of solids from the unit. Figure 5-6, *Concrete Grease Interceptor Observations*, taken after pumping of the grease interceptor, shows the deterioration of the concrete walls and exposed rebar inside the concrete grease interceptor. Even with the deteriorated concrete and exposed rebar, Darling International was able to clean the concrete grease interceptor efficiently.

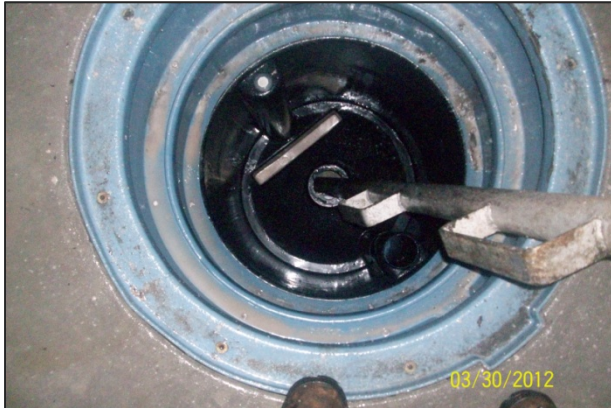
**Figure 5-7, Trapzilla® Unit After Pumping**

Figure 5-7, *Trapzilla Unit After Pumping*, shows the inside of the Trapzilla® after thorough pumping; the photo on the left shows the pumping of the solids compartment of the Trapzilla®. The materials did not adhere to or solidify on the walls of the Trapzilla® unit, and the sloped funnel shape of the Trapzilla® forced the solid materials to the center, where they could be removed by the suction nozzle. However, due to the configuration of the Trapzilla®, it was difficult to see whether all residual solids were removed during pumping.

Interior of the Trapzilla® Immediately After Pumping on 3/30/2012

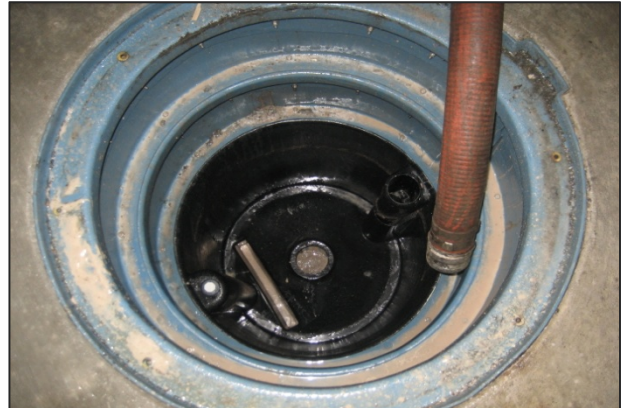
Interior of the Trapzilla® Immediately After Pumping on 5/1/2012

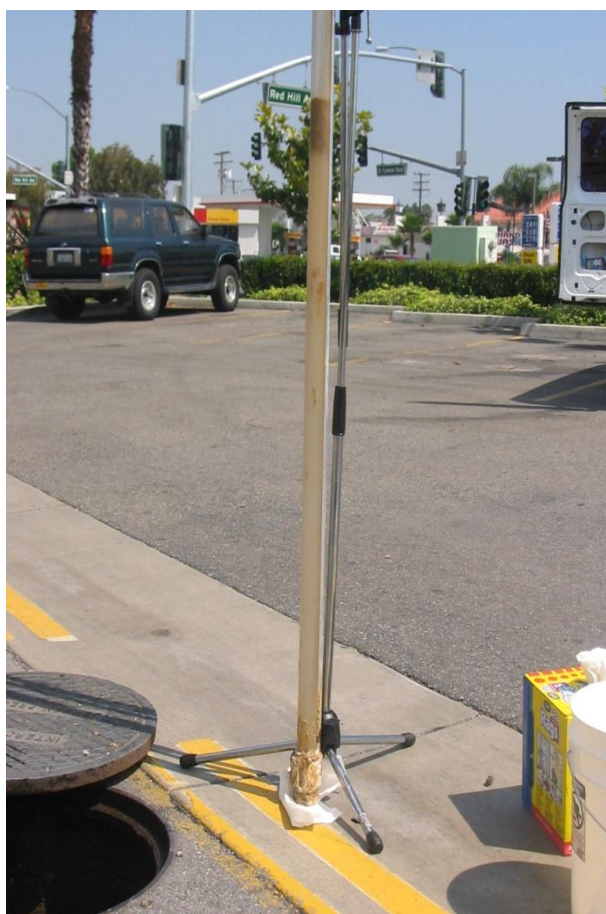
Accumulation Is Less Than 25%

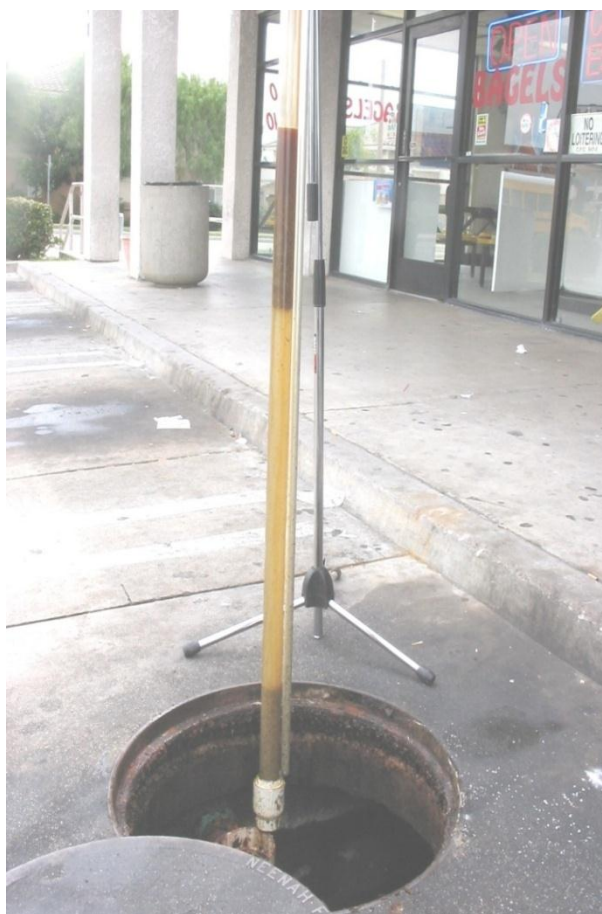
Accumulation Is Greater Than 25%

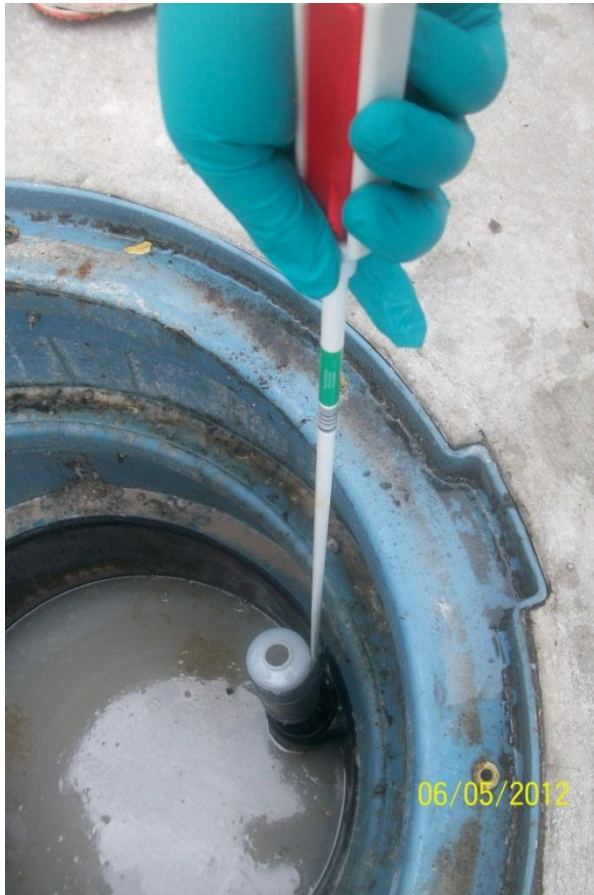
1,000 mL Container Used to Collect Wastewater Samples from the Trapzilla®

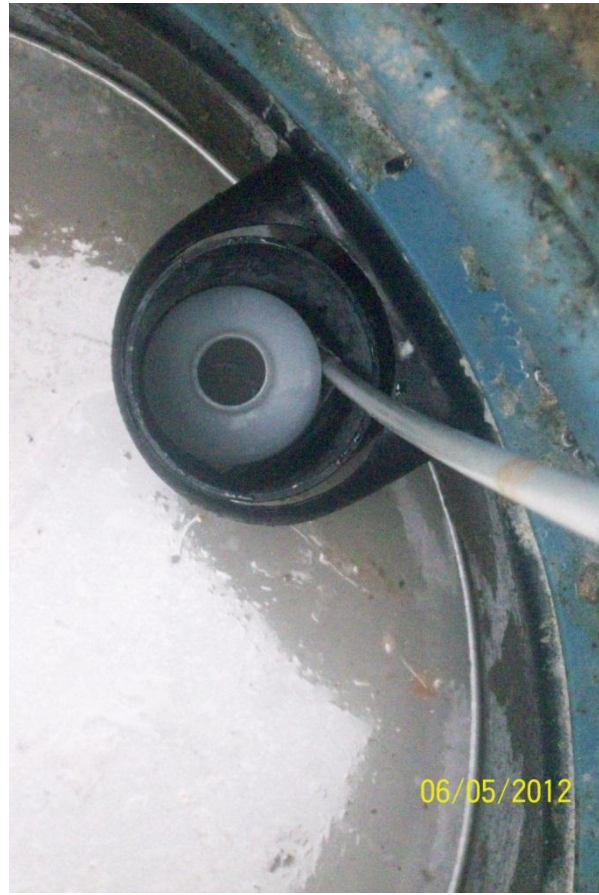
1,000 mL Container Submerged in the Trapzilla® Effluent Pipe

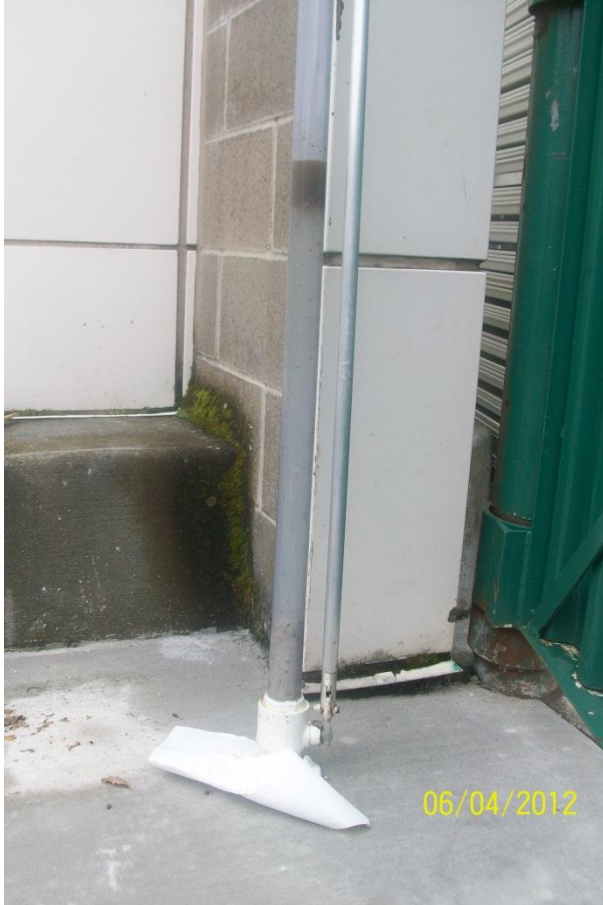
Dip Stick Probe Used to Verify the Pumping Frequency

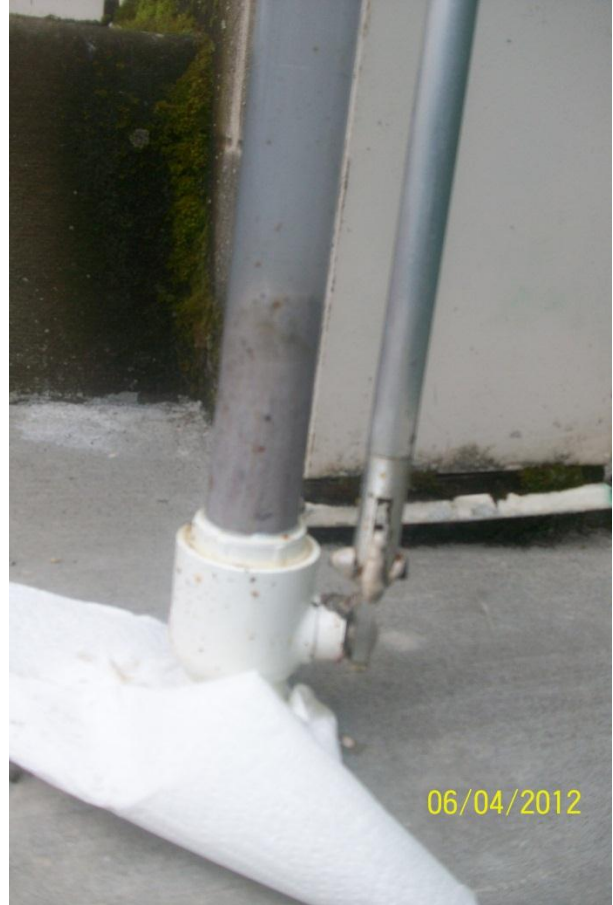
Level of Solids Accumulated at the Bottom of the Dip Stick Probe
